Test report

**Test report relating to a glass product according to European standard EN 1279-3:2018, concerning the product marked as: Isicam
Manufactured by: BALABAN ISI ve CAM SAN. TİC.LTD. ŞTİ.**

Report number	8926155-16
Date	26 February 2020
Author(s)	Mr. M.A.A.M. Schets, B.Sc.
Client	NEDEX KİMYA SAN ve Tic AŞ Tatlisum mah araci sok no 8 34774 Umraniye Istanbul Turkey
Project number	89216155
Project name	19.A367 - EN1279-3 sys 6
Number of pages	12

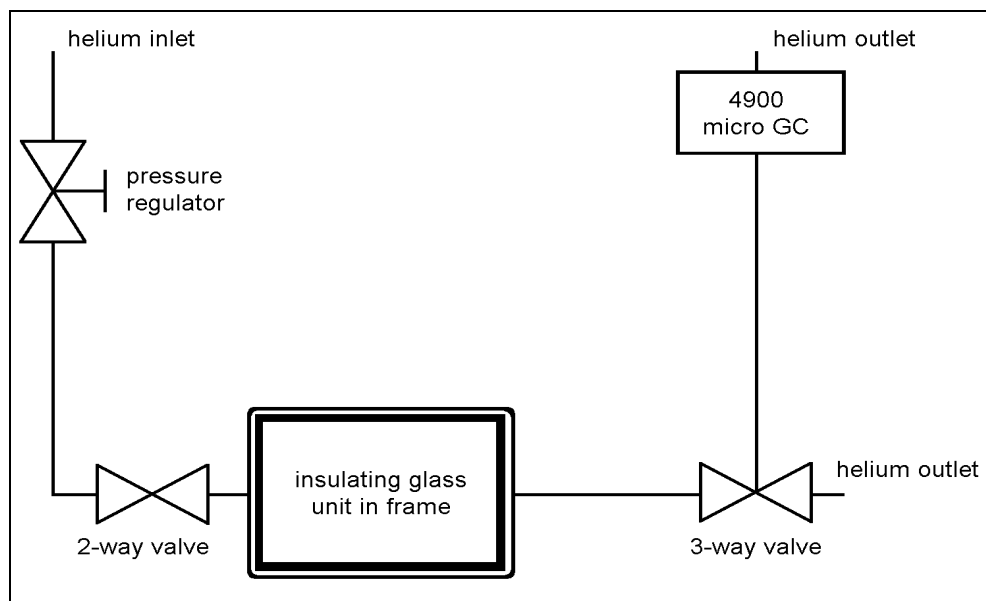
The schematic diagram of the equipment is as follows:

After the climate test the specimens are stored at standard laboratory conditions for at least 2 weeks and maximal 6 months. Of minimal two specimens (IGU's) the gas leakage is determined after the climate exposure. The specimens are placed in a container (frame) that encloses the unit with some space left between the IGU and the container.

After placing the IGU's in the test containers and closing the containers are purged with a helium flow of ± 150 ml/min for 1 hour. At the end of this purge time, the inlet and outlet valves are closed in succession to ensure an atmospheric pressure inside the container (start of standing time). Before and after a the standing time the gas in the container is measured for argon, oxygen and nitrogen concentration using a gas chromatograph (4900 Micro GC). This is repeated a number of times to reaches sufficient constancy of the values.

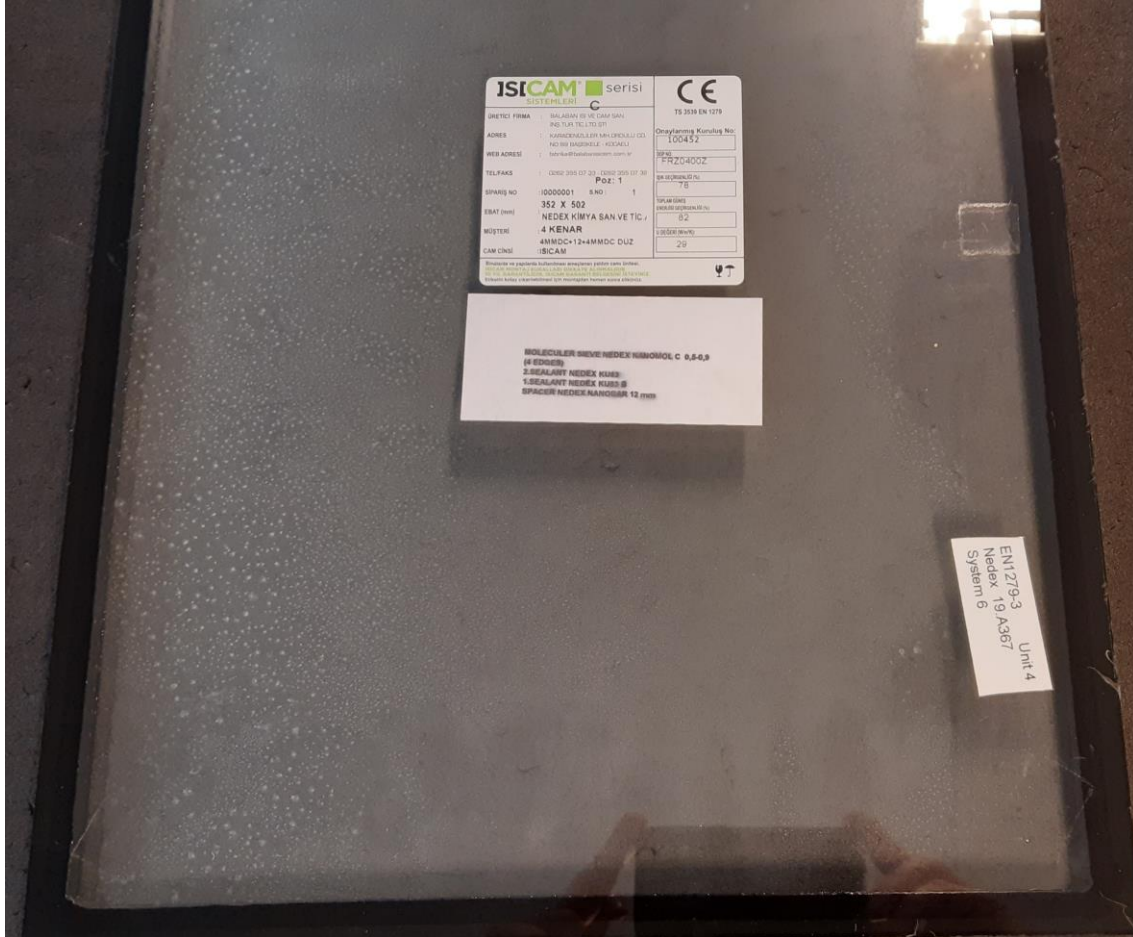
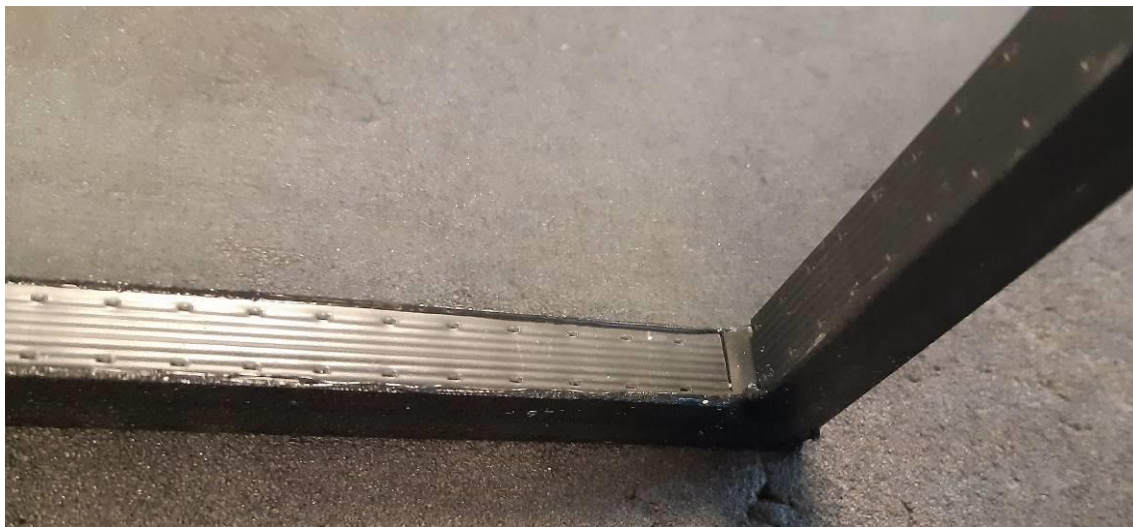
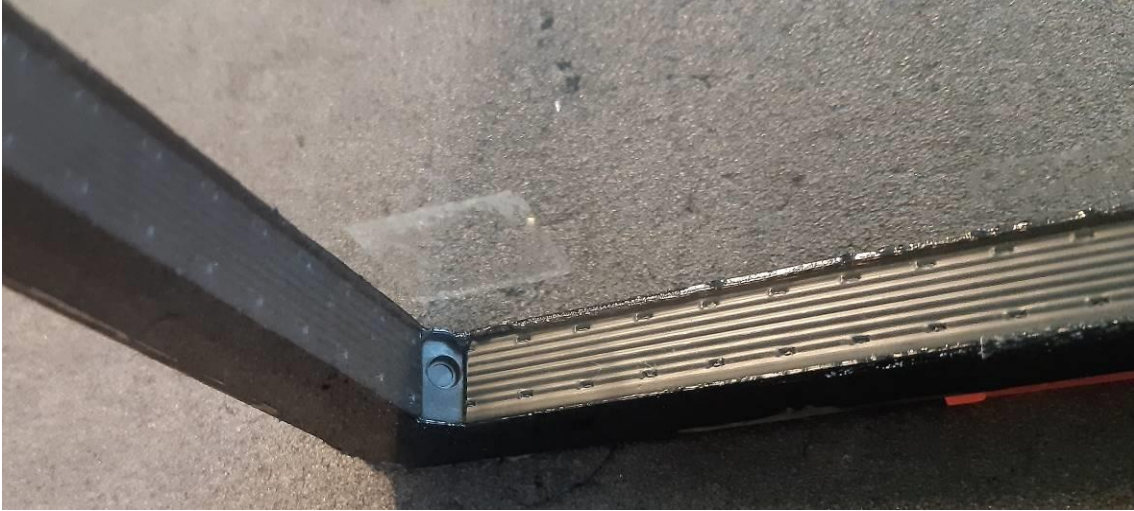
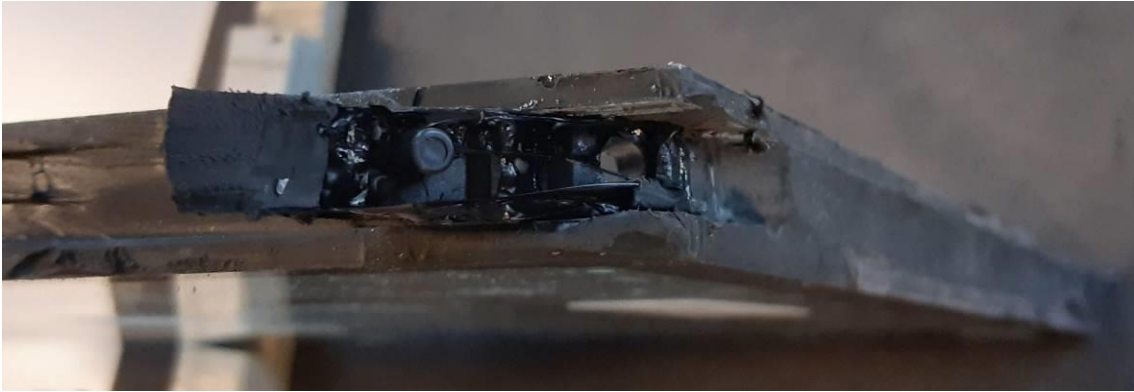
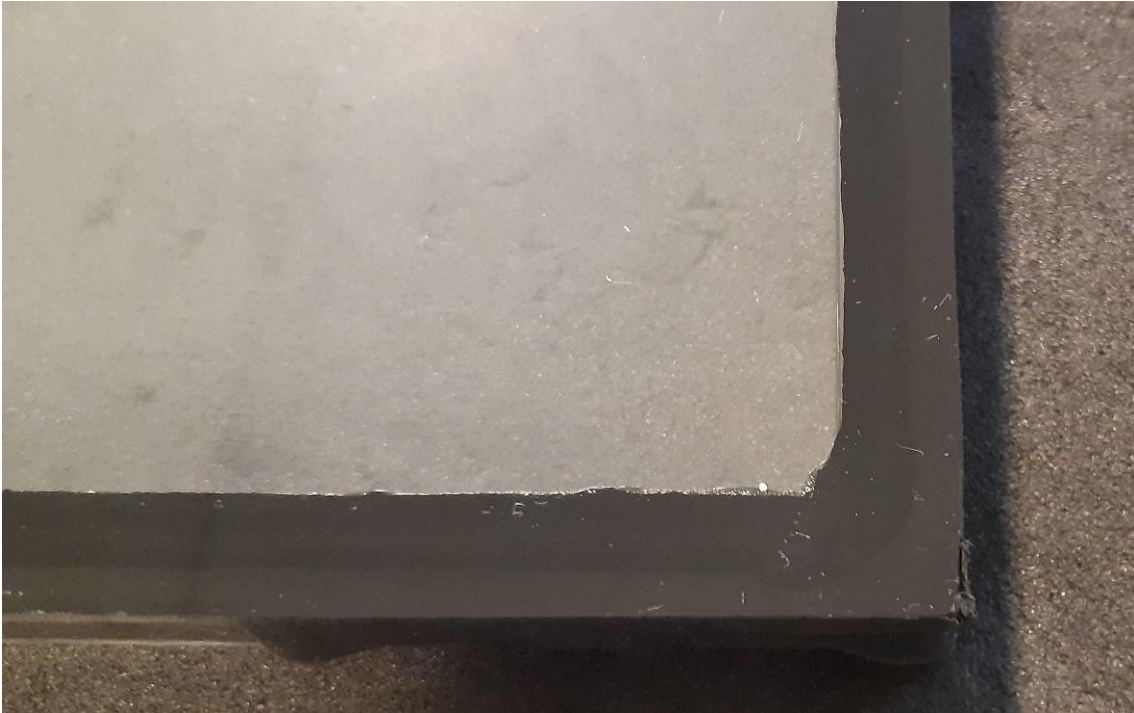
Appendix B, Pictures of the test specimen

Insulating glass units – Declaration manufacturer	
Manufacturer	BALABAN ISI ve CAM SAN. TİC.LTD. ŞTİ.
Address of manufacturer	Karadenizliler Mh. Ordulu Cd. No:89 BAŞISKELE/KOCAELİ
Plant	Karadenizliler Mh. Ordulu Cd. No:89 BAŞISKELE/KOCAELİ
Line ID where the samples are made	Line 1
Date of production	01.10.2019
Product Name	Isicam
System description, file number	Balaban
Exterior dimensions	502 mm x 352 mm
Total thickness	20 mm
Construction	4 float / 12 / 4 float (mm)
Spacer	Nedex Nanobar
Spacer material	Plastic
Corner construction	with corner keys
Corner keys	None
Linear connector	None
Desiccant	Nedex Nanomol-C
Desiccant type	Calcium oxide
Standard Moisture adsorption capacity (T_C)	18.1±0.5 %
Desiccant amount	4 sides filled
Outer sealant	Nedex PS 018
Polymer type	Polysulfide
Average sealant depth on spacer back (u)	± 3 mm
Average sealant width on glass surface (s)	± 4 mm
Inner sealant:	Nedex PIB 996
Polymer type:	Polyisobutylene

Corner construction	corner keys
Average sealant depth on spacer back (u)	3.5 - 4.5 mm
Average sealant width on glass surface (s)	5 - 6.5 mm
Average inner sealant width (r)	5.5 - 6.5 mm
Closing of gas filling holes	plug with butyl
Edge deletion	N/A
Special features	None
Markings	None
